**CREEP-RUPTURE AND FATIGUE BEHAVIORS OF  
NOTCHED OXIDE/OXIDE CERAMIC MATRIX COMPOSITE  
AT ELEVATED TEMPERATURE**

THESIS

Mark A. Sullivan, Captain, USAF  
AFIT/GAE/ENY/06-M30

***AIR FORCE INSTITUTE OF TECHNOLOGY***

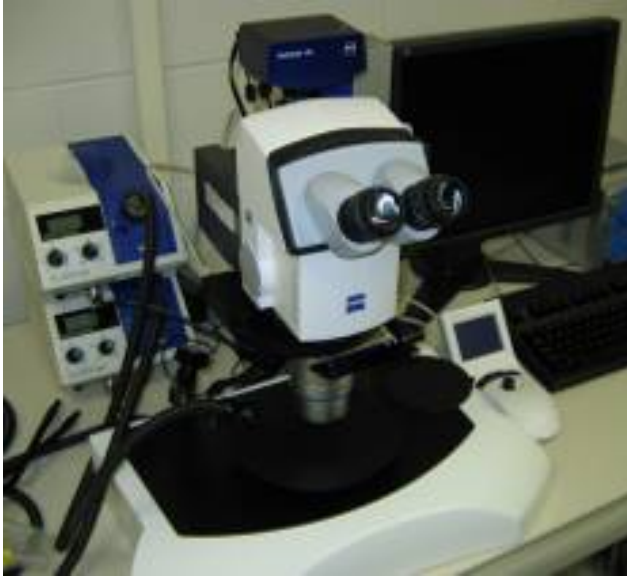
**Figure 11. Zeiss Discovery.V12 microscope**

Images of fracture surfaces were made using both an optical microscope and a scanning electron microscope (SEM). The optical microscope was a Zeiss Discovery.V12 with a Zeiss AxioCam HRC to capture images and the SEM used was a FEI Quanta 200, shown respectively in Figure 11 and Figure 12.

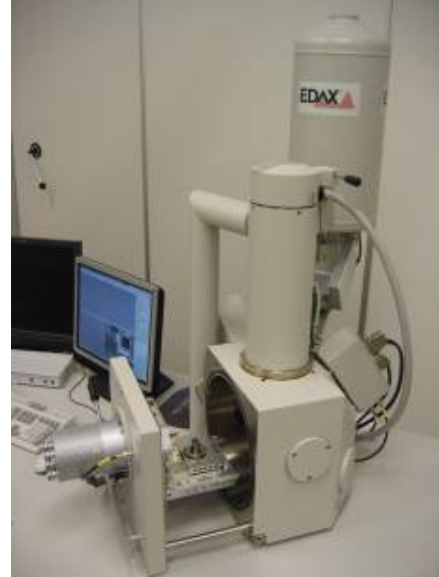
**Figure 12. Quanta 200 SEM**

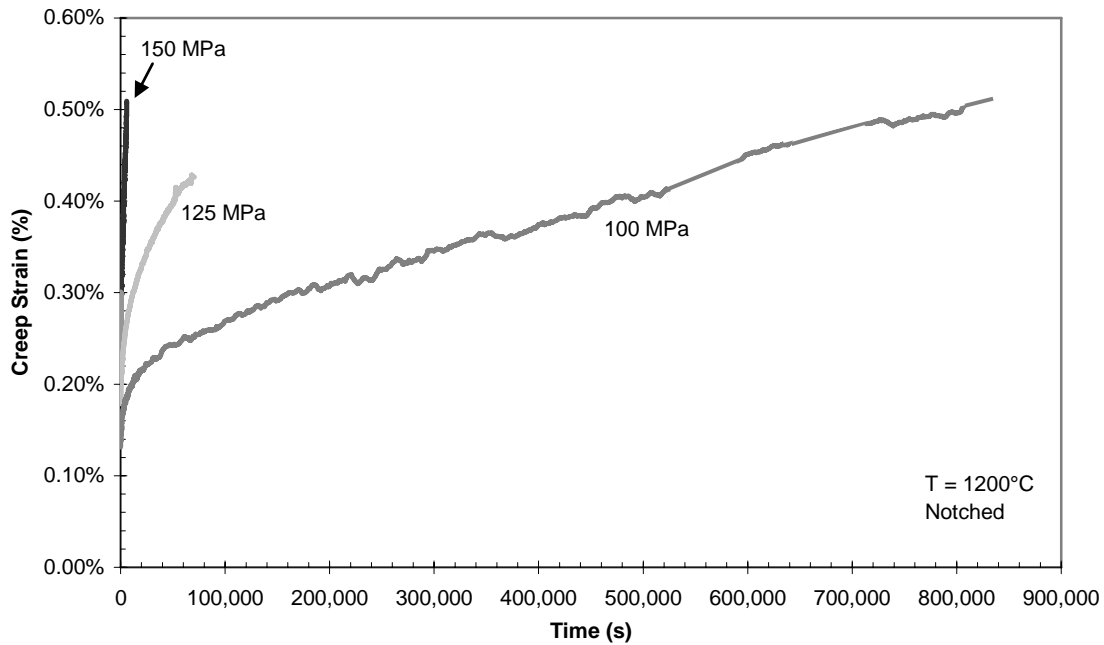
**Figure 17. Creep strain vs. time for notched N720/A at 1200°C**

strain gage exhibited slipping during the latter half of the test. Despite this slipping, it is apparent the secondary region extends to 800,000 s. However, it is impossible to determine whether or not tertiary strain growth occurred during the last period of the test.

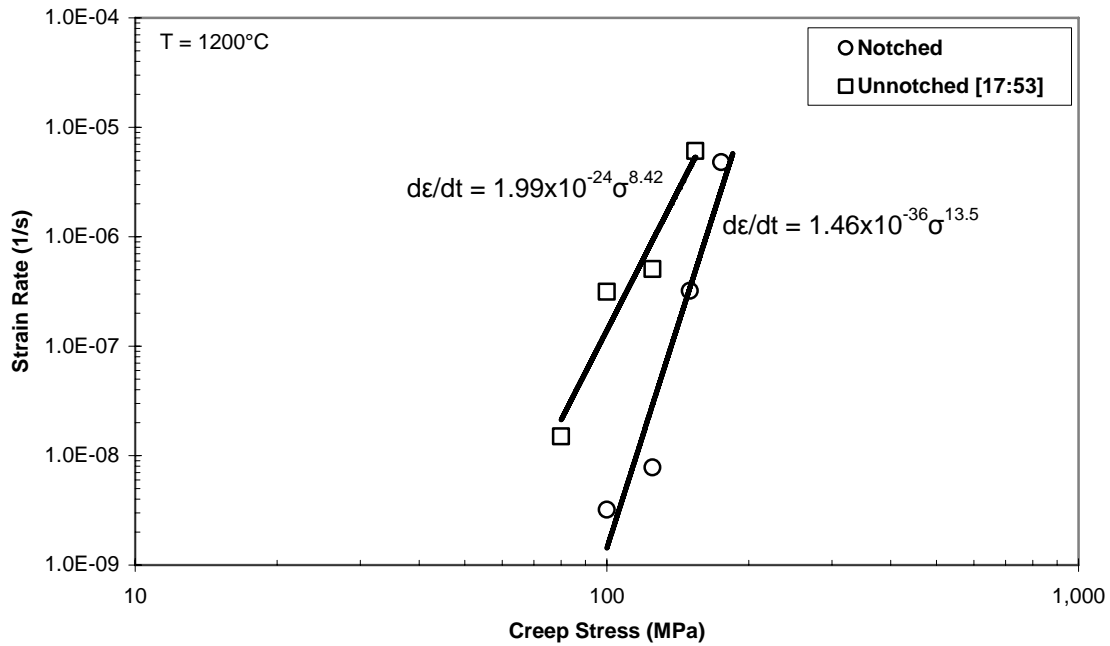
**Figure 21. Minimum creep rate vs. creep stress for N720/A at 1200°C**

average strain for the notched specimens makes it impossible to directly compare constants for the two curves. The lower strain rate for the notched specimen is a byproduct of stresses dropping at increasing distance from the net-section.

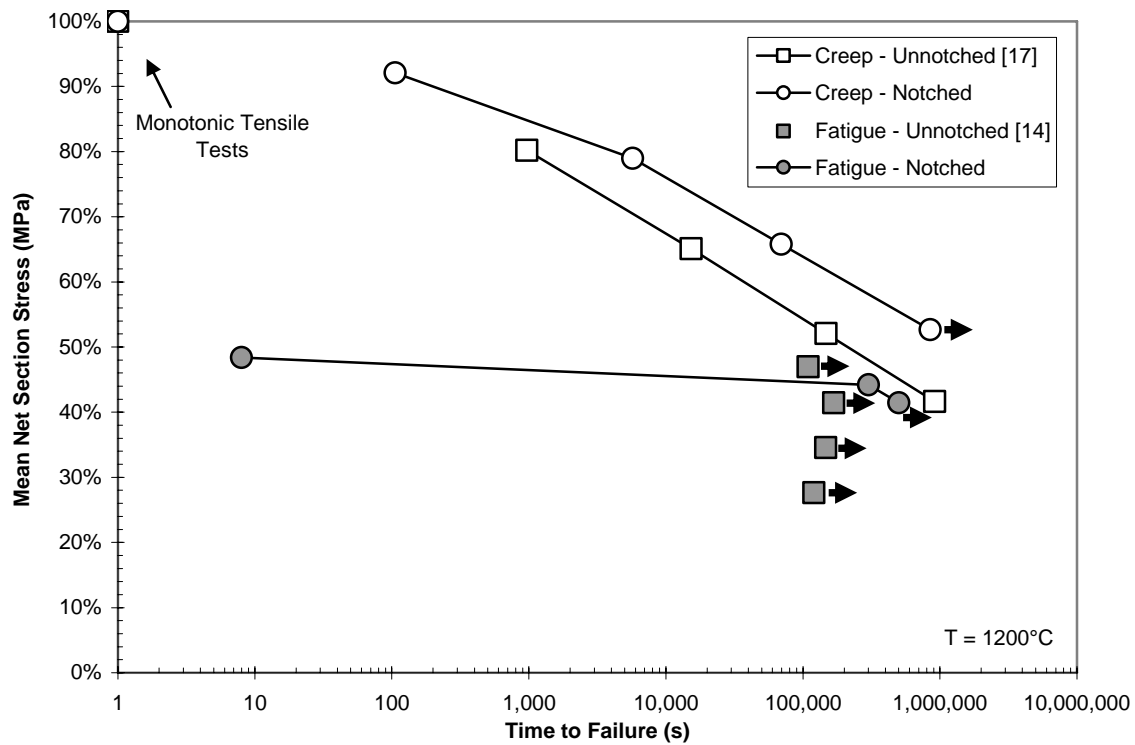
**Figure 30. Mean fatigue and creep stress vs. time to failure for N720/A at 1200°C**

Figure 29 also shows the 175 MPa fatigue test, with mean stress of 92 MPa, having higher average strains than the 100 MPa creep test. This shows fatigue loadings with maximum stress at 92% of the UTS incorporate notable damage mechanisms besides creep. The plot of mean stress versus time to failure shown in Figure 30 indicates this additional damage results in a significant reduction in life. The log-scale plot also shows mean fatigue stresses below 45% UTS having approximately the same slope as the S-t curves for notched and unnotched creep. This same region also indicates mean fatigue stress for notched specimens must be 25% less than the creep stress of a similarly notched specimen to achieve the same lifespan.
